The historic 1854 North Fork Ditch

Visible along the Shoreline Equestrian Trail between Sterling Pointe and Beeks Bight, Placer County

by Robert H. Sydnor, M-LBHA, M-AERC
LBHA Trails Committee, October 2008 LBHA Newsletter

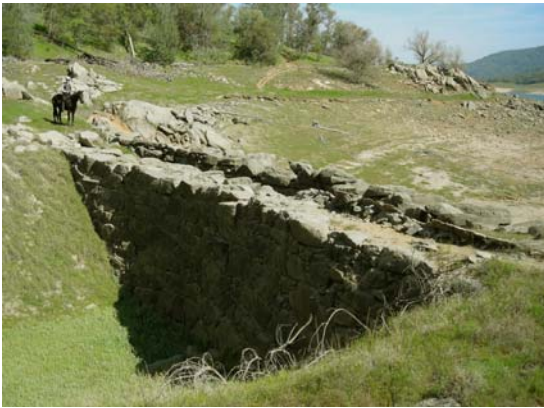
Stone viaduct along the North Fork Ditch.

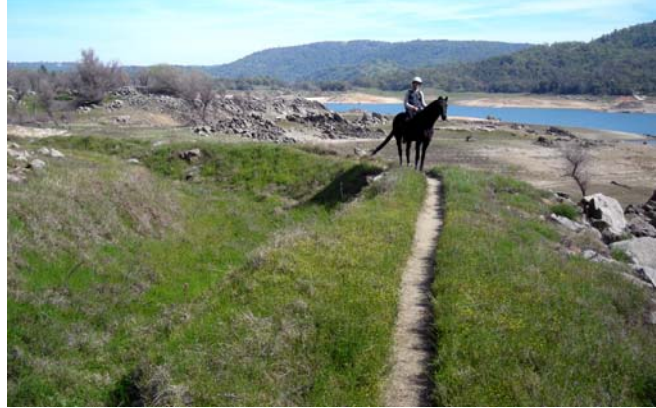
Water ditch at left, with horse trail on the outside berm.

The North Fork Ditch was designed to be a trapezoid five feet wide at the base, eight feet wide at the top, with a depth of about 3 feet. It was designed to carry about 3,000 "miner's inches" of water (=ancient volumetric terminology) at a steady low velocity. For about 68 years the ditch was unlined gravel and rocks which significantly leaked and was subject to winter erosion. There were a number of isolated cabins (now gone) where full-time "ditch monitors" lived and performed daily maintenance with shovels along the 33 miles. About 1925, the ditch was partly lined with cement to decrease leakage.

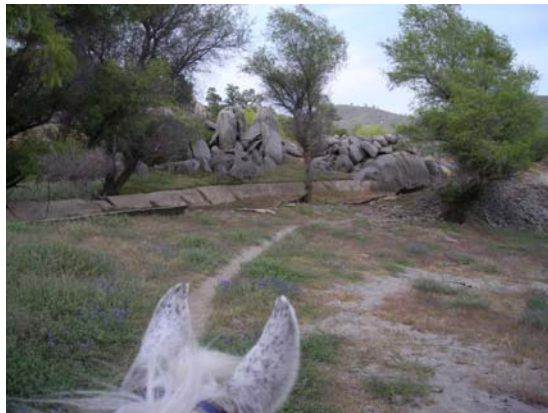
Ditch was lined with cement about 1925.

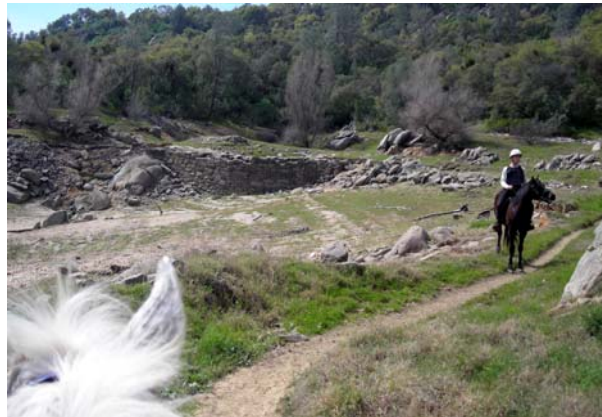
Ditch is silted-in and now forms the trail bed.
